## **New, Unusual Running Conditions on 1995-2001 ThunderMax Marelli Touring Models and 2001-2005 Delphi Type Models**

v.07172012

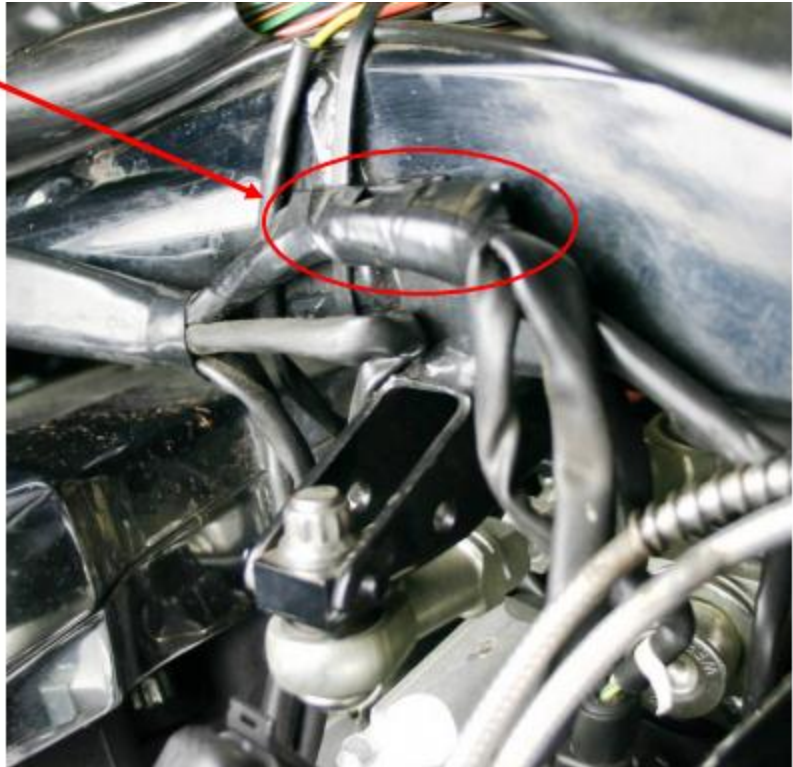
The fuel tank must be removed to inspect the engine harness and clips which attach to the m/c backbone on the frame. Many harnesses installed on motorcycles between 1995 and 2003 were tied too tightly to the backbone. When the engine shakes in the chassis, the wiring is pulled which slowly degrading the integrity of the wires. Additionally, the original wiring has already been subjected to 10 to 15 years of stress, heat and vibration, making this area a big target for locating problems. The harness must be released from the last frame clip to allow enough slack to reposition the connectors for the Delphi throttle body. Stress from constant tension could be pulling strands of wires out of the engine harness, creating intermittent and inconsistent engine operation. (See image of harness clip/wiring branches below)

TPS and MAT sensors at rear of throttle body. Note angle of wiring harness as it enters the terminal connector.

The harness clip may be released or repositioned to allow enough slack for the wiring branch that leads to the TPS and the MAT sensors to prevent excess stress on the wires & terminals.

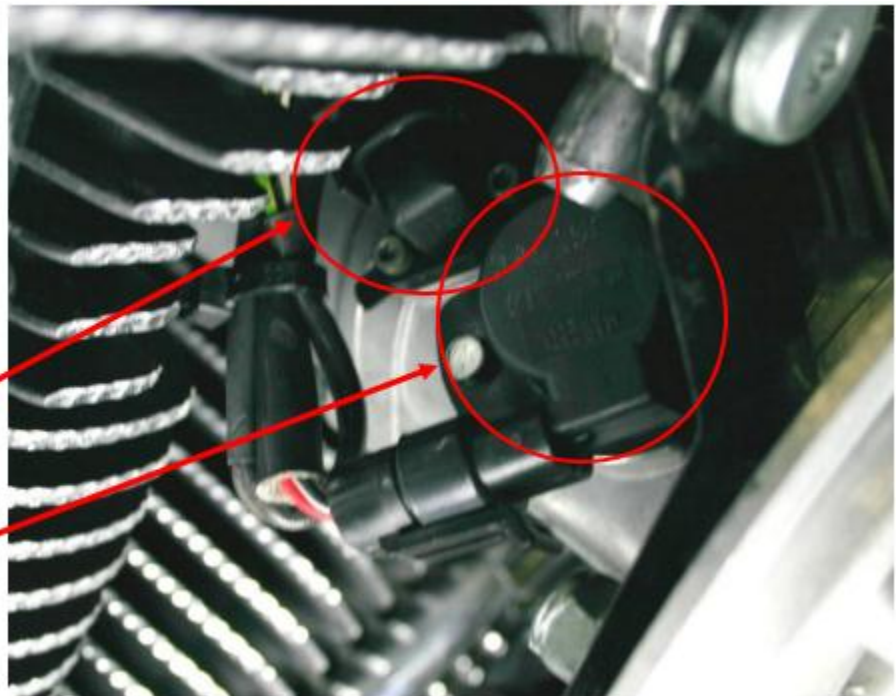
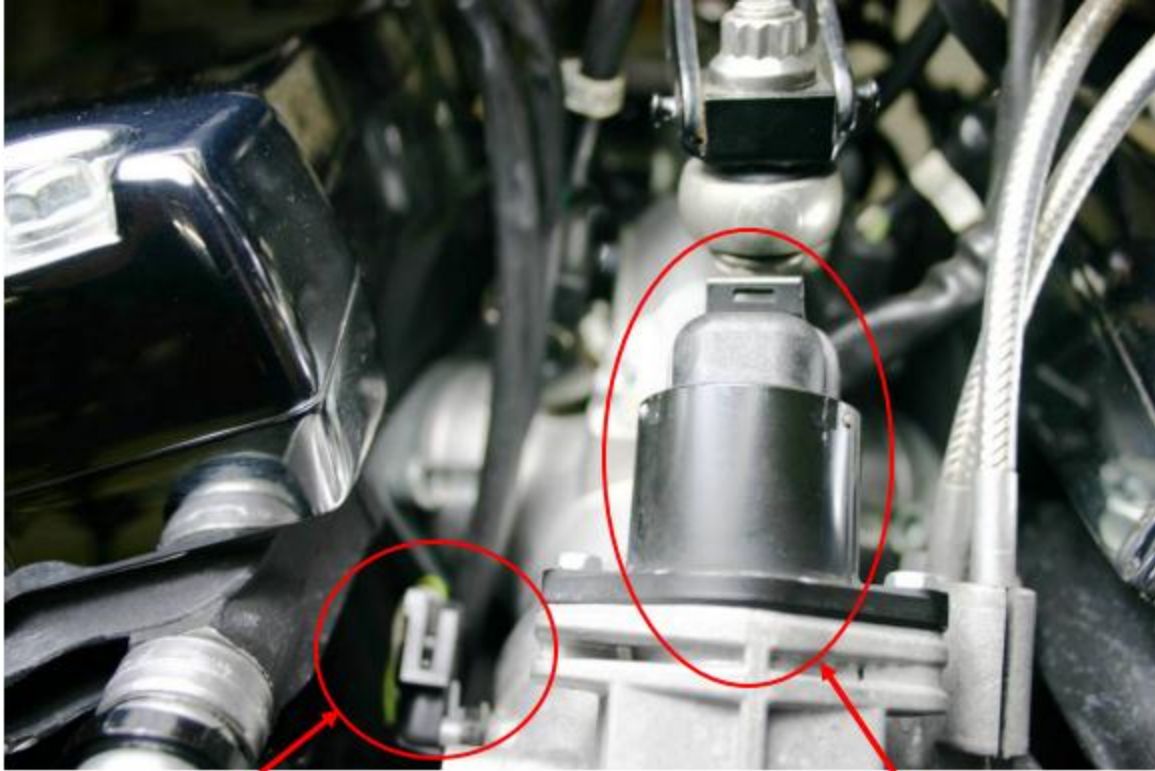
**MAT harness connector**  
(Intake Air Temp)

**IAC motor**  
(Idle Air Control)

The MAT harness connector and the IAC motor are shown above.

Through monitoring of gauges in the SmartLink software, we have discovered abnormal readings for throttle position, manifold air temp and erratic IAC movement. These will lead to poor performance, poor idle quality or abnormal fuel delivery. These conditions may be intermittent. Wires may be down to a few strands, broken inside the plastic coating, or broken at the terminal in the connector, resulting in intermittent or, eventually, no contact.

Troubleshooting this type of issue can be very time consuming and costly. Some technicians have reported changing results by grabbing, shifting or pulling on engine harness wires. A more accurate method would be to remove the pins from each TB sensor plug and locate damaged or broken wire in the harness. A common technique is to remove the pin from the sensor, and the damaged wire could pull right out of the harness. This will require repair or replacement to the EFI engine harness.

Note- A working, yet faulty, IAC motor will provide erratic A/F readings and poor performance. Replacing the IAC motor is a quick process worth trying.

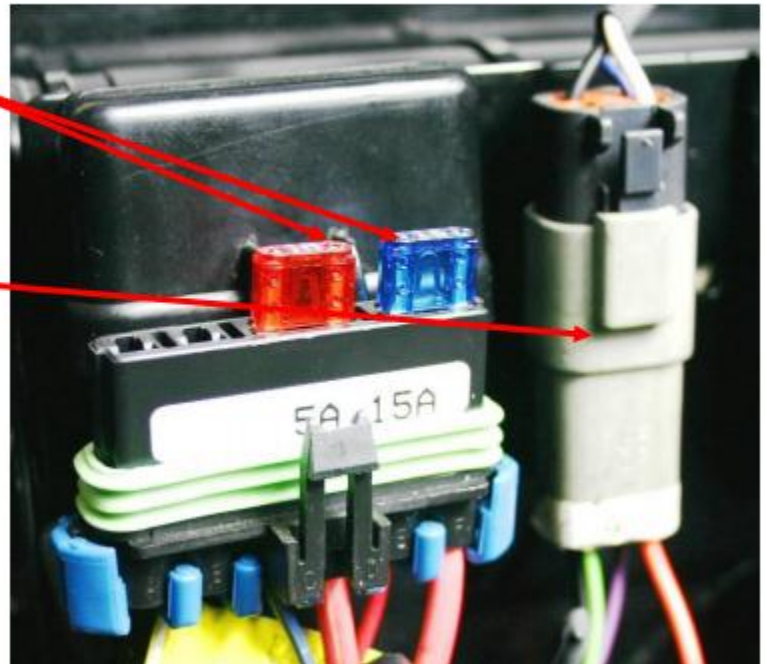
Corrosion at the terminals of the fuse panel, data port or other connectors is commonly found. Terminal corrosion may be hidden, and may require the removal, inspection and cleaning/repair of the fuse panel.

A typical arrangement from a 2001 model is shown in this view of the exposed fuse block and Data Link.

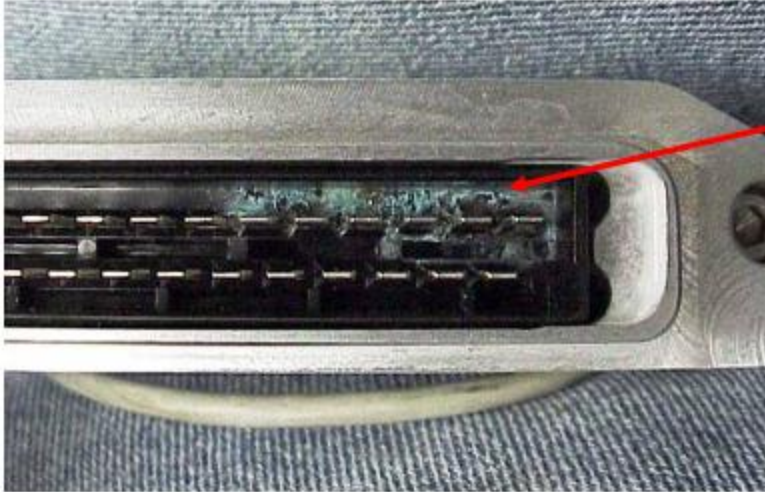
Corrosion may also be found in the ECM harness terminal. Disassembly and careful inspection of the ECM terminals and housing will be required to properly diagnose a problem. Thoroughly clean any corrosion and repair any weak, broken or questionable wiring as needed. The image below shows damage to a Marelli model ThunderMax ECM as a result of power washing a motorcycle with the side cover removed, water invades past the seal entering the harness connector and settling around the ECM connector blades.

An example of ECM damage from corrosives entering the ECM harness connector.

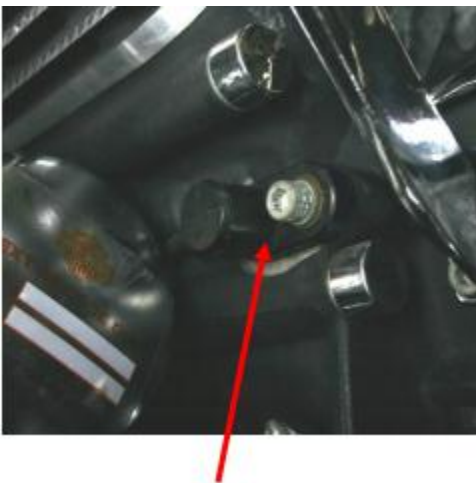
Abnormal operation could also be related to degradation of sensors. Partial failure of a sensor may not trigger a diagnostic code. If not replaced at install, we strongly recommend replacing the crank position sensor as a routine step during the installation of all ThunderMax Marelli conversion kits. A faulty cylinder head temperature sensor will cause inconsistent performance problems. Cam position sensors, where applicable, should be disconnected as noted in the ThunderMax M.M. kit instructions and good, clean voltage with a reliable grounds are essential. The Diagnostic Trouble Code window in SmartLink offers an overview of sensor status. Abnormal readings from the various sensors can also be detected using the monitor function in SmartLink.

Crank Position sensor is shown above near the oil filter and below the front cylinder.

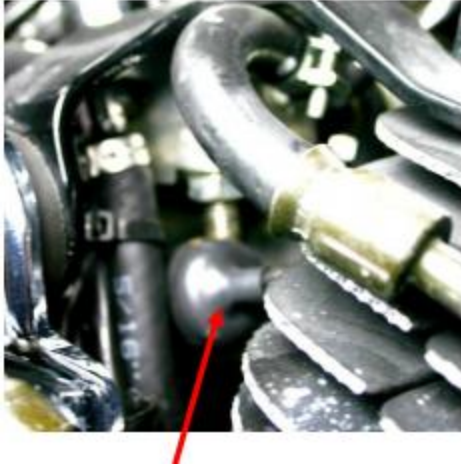
Head Temp sensor is shown above at the upper left rear of the front cylinder.
