HOW TO:

New, Unusual Running Conditions on 1995-2001 ThunderMax Marelli Touring Models and 2001-2005 Delphi Type Models

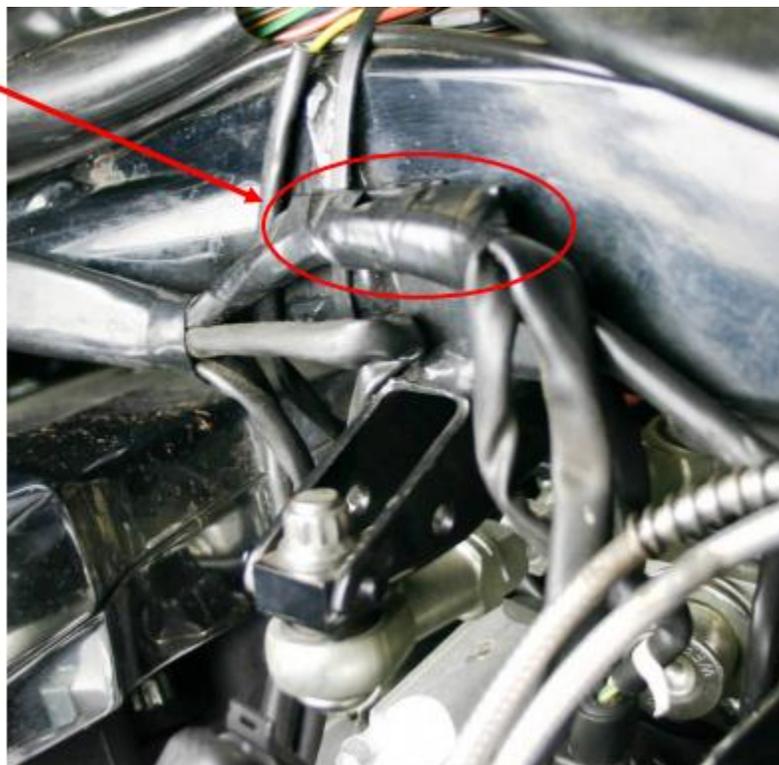
TPS and MAT sensors at rear of throttle body. Note angle of wiring harness as it enters the terminal connector.

MAT sensor
(Intake Air Temp)

TPS sensor
(Throttle Position)

Through monitoring of gauges in the SmartLink software, we have discovered abnormal readings for throttle position, manifold air temp and erratic IAC movement. These will lead to poor performance, poor idle quality or abnormal fuel delivery. These conditions may be intermittent. Wires may be down to a few strands, broken inside the plastic coating, or broken at the terminal in the connector, resulting in intermittent or, eventually, no contact.

The harness clip may be released or repositioned to allow enough slack for the wiring branch that leads to the TPS and the MAT sensors to prevent excess stress on the wires & terminals.

Troubleshooting this type of issue can be very time consuming and costly. Some technicians have reported changing results by grabbing, shifting or pulling on engine harness wires. A more accurate method would be to remove the pins from each TB sensor plug and locate damaged or broken wire in the harness. A common technique is to remove the pin from the sensor, and the damaged wire could pull right out of the harness. This will require repair or replacement to the EFI engine harness.

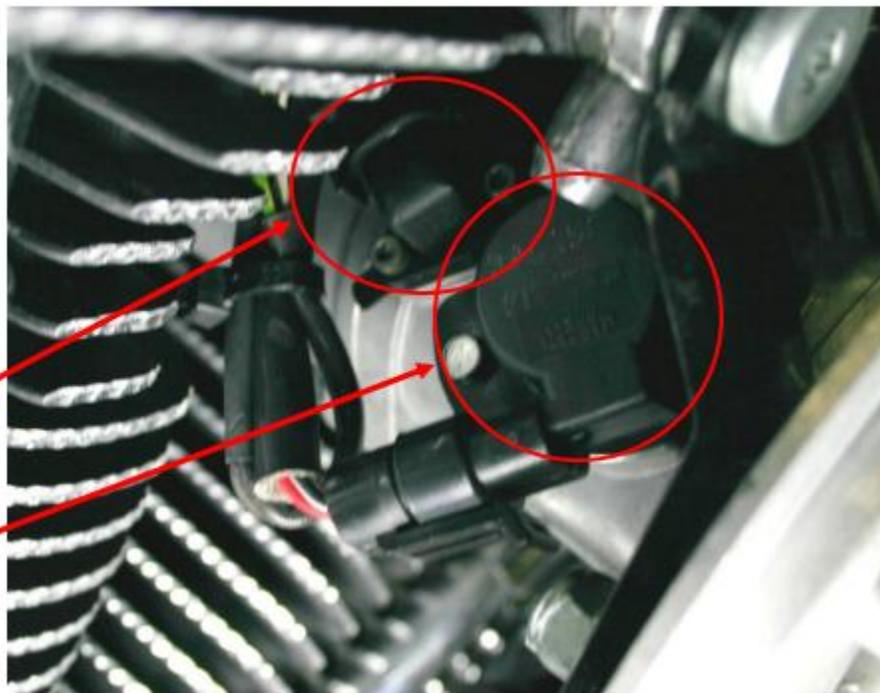
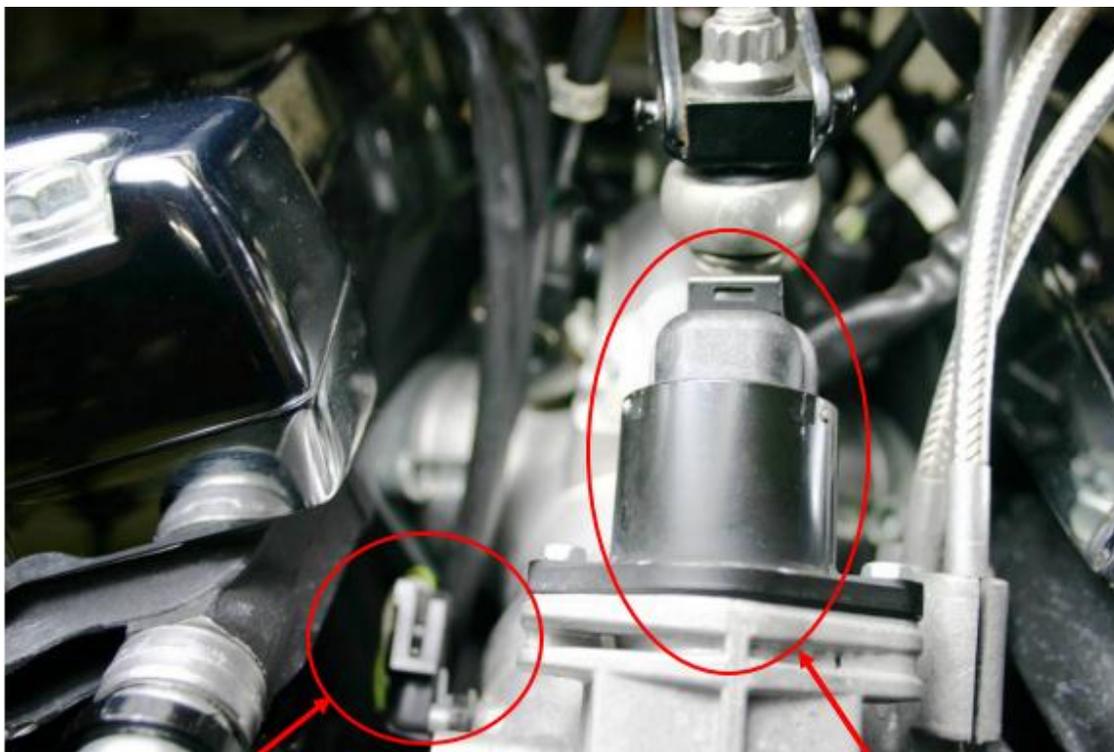
MAT harness connector
(Intake Air Temp)

IAC motor
(Idle Air Control)

The MAT harness connector and the IAC motor are shown above.

Note- A working, yet faulty, IAC motor will provide erratic A/F readings and poor performance. Replacing the IAC motor is a quick process worth trying.

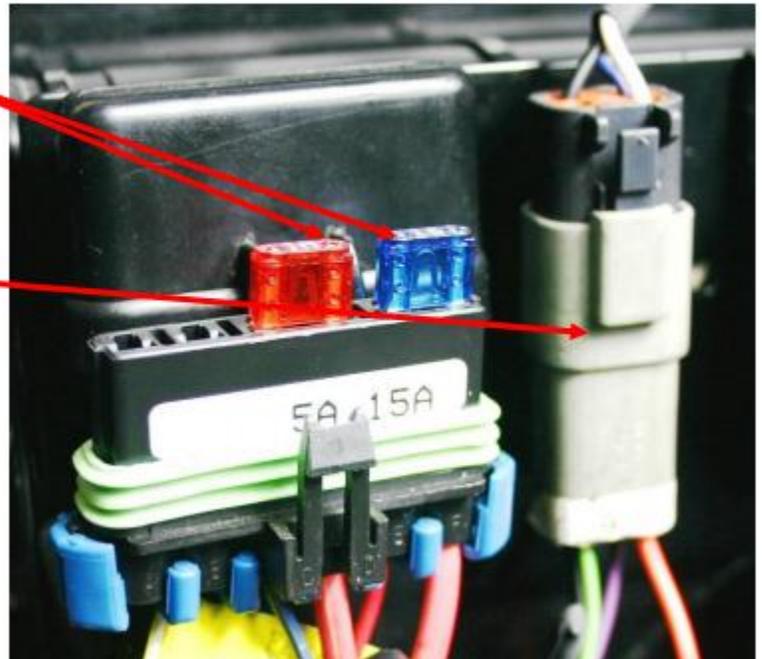
Corrosion at the terminals of the fuse panel, data port or other connectors is commonly found. Terminal corrosion may be hidden, and may require the removal, inspection and cleaning/repair of the fuse panel.

A typical arrangement from a 2001 model is shown in this view of the exposed fuse block and Data Link.

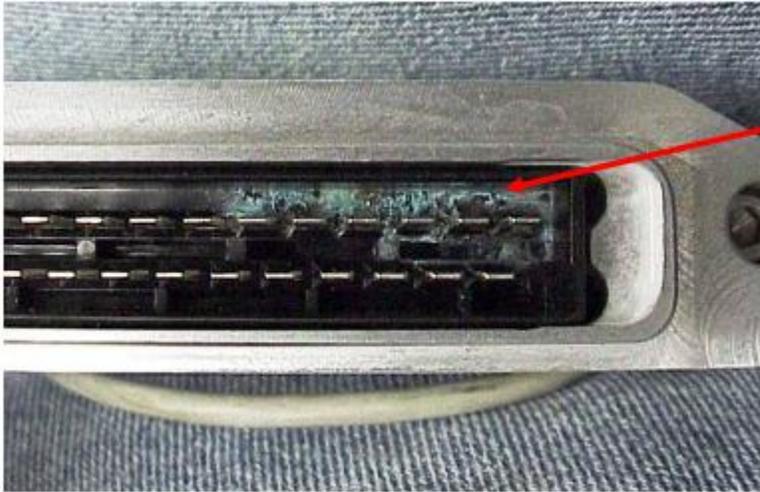
Corrosion may also be found in the ECM harness terminal. Disassembly and careful inspection of the ECM terminals and housing will be required to properly diagnose a problem. Thoroughly clean any corrosion and repair any weak, broken or questionable wiring as needed. The image below shows damage to a Marelli model ThunderMax ECM as a result of power washing a motorcycle with the side cover removed, water invades past the seal entering the harness connector and settling around the ECM connector blades.

An example of ECM damage from corrosives entering the ECM harness connector.

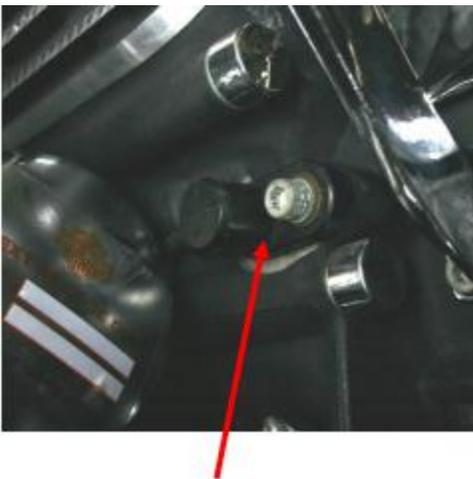
Abnormal operation could also be related to degradation of sensors. Partial failure of a sensor may not trigger a diagnostic code. If not replaced at install, we strongly recommend replacing the crank position sensor as a routine step during the installation of all ThunderMax Marelli conversion kits. A faulty cylinder head temperature sensor will cause inconsistent performance problems. Cam position sensors, where applicable, should be disconnected as noted in the ThunderMax M.M. kit instructions and good, clean voltage with a reliable grounds are essential. The Diagnostic Trouble Code window in SmartLink offers an overview of sensor status. Abnormal readings from the various sensors can also be detected using the monitor function in SmartLink.

Crank Position sensor is shown above near the oil filter and below the front cylinder.

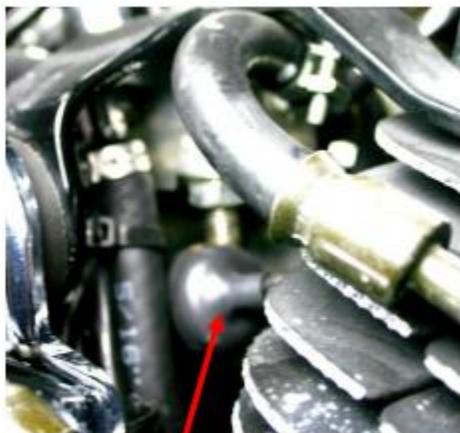
Head Temp sensor is shown above at the upper left rear of the front cylinder.
