Gen II or Marelli TPS Cursor Problems

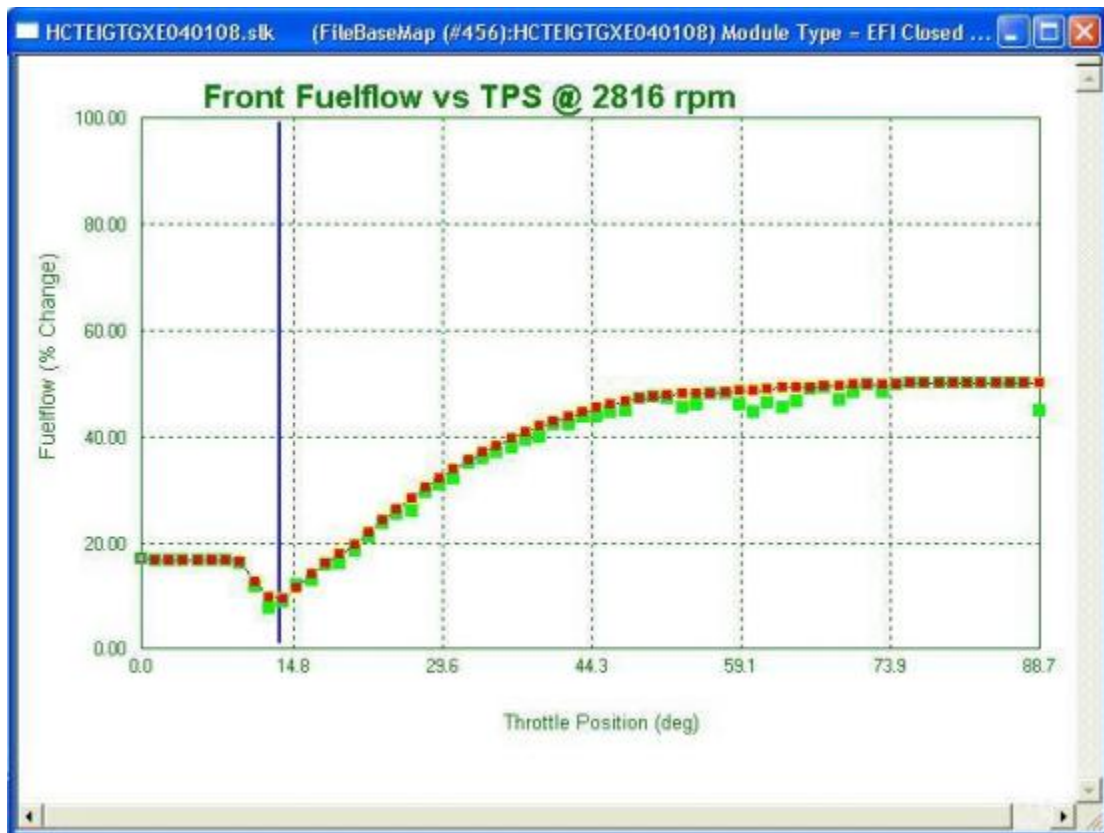
Normal TPS Cursor at idle

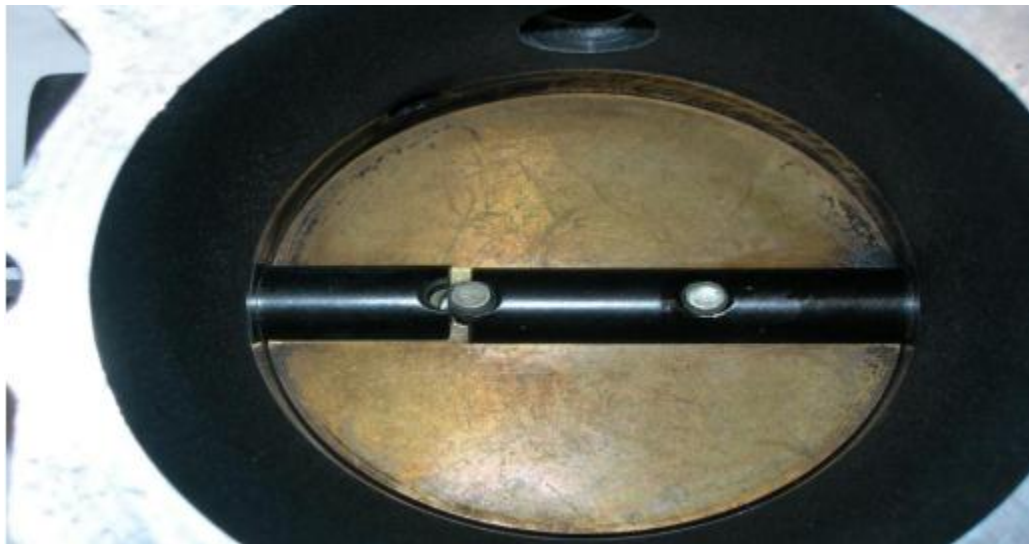
Throttle Shaft Inspection

We see several cases a month of cracked or broken throttle shafts. These are usually found on 2001-2005 style throttle bodies; TPS can be severely erratic with possible high unstable idle speed. Remove the throttle body from the manifold to perform an inspection.
