Missing Vacuum Cap

How to inspect for a Missing Vacuum Cap:

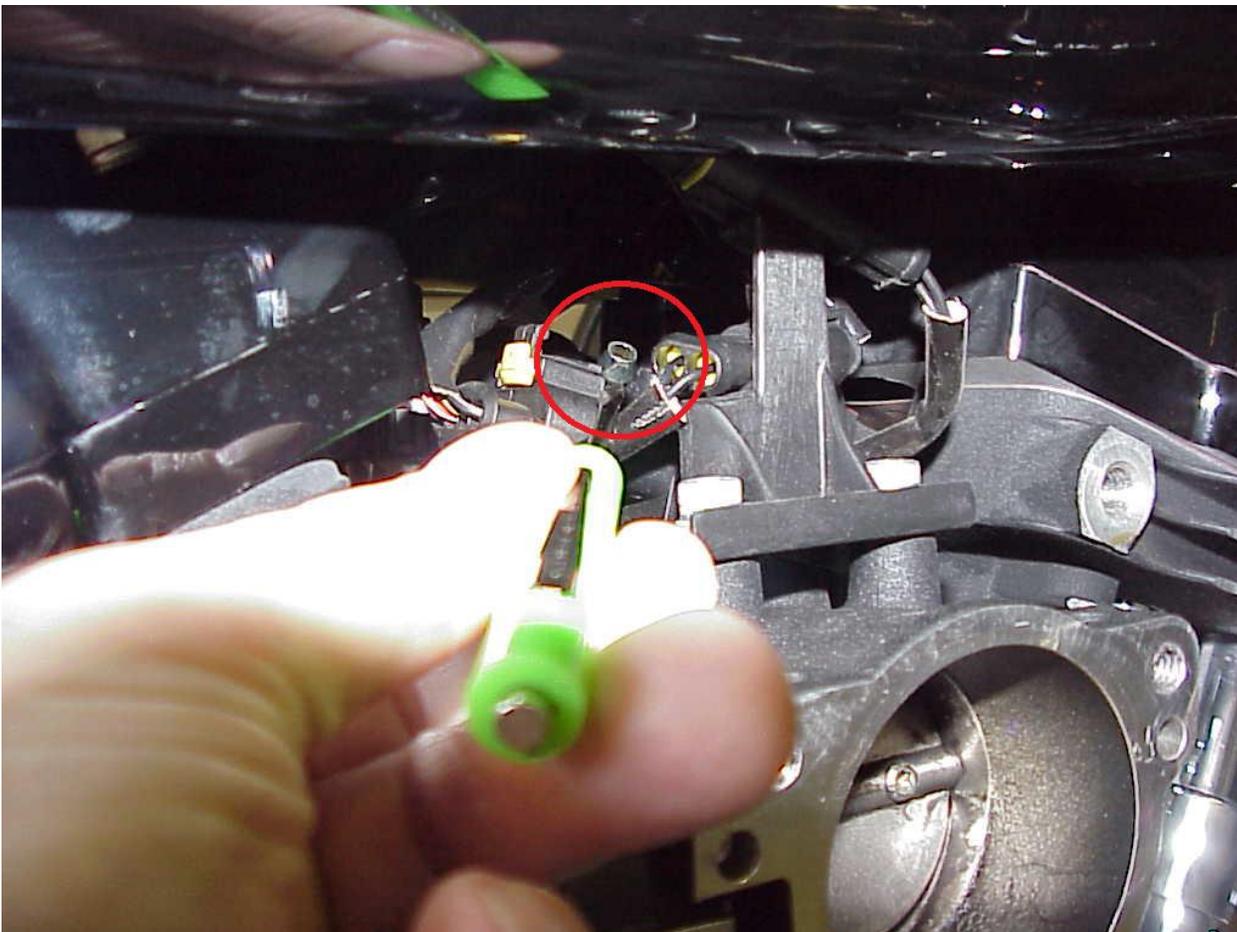
1. Approach the RIGHT side of the motorcycle
2. Using a light, look under the tank at the Air Cleaner location, on top of the Throttle Body
3. It is hard to see and sets back in between the cylinders, on top of the Throttle Body
4. There is a ¼" steel vacuum tube
5. This steel vacuum tube should have a rubber cap on it
6. Verify the rubber cap is in place
7. If the rubber cap is missing, it must be replaced

Note: Refer to "Map - Reloading Your Base Map" if the cap is found to be missing.

NOTE: Auto parts stores will have rubber vacuum caps OR you can use a short piece of vacuum hose with a small bolt in the end (acting as a plug). The "hose and bolt" arrangement is actually more secure than the rubber caps. A little ugly but does not show.
